7 **CEDAR HILL LAKE NO. 2 AND NO. 3 DAMS**

8 **JEFFERSON COUNTY, MISSOURI**

6 **PHASE I INSPECTION REPORT**
1 **NATIONAL DAM SAFETY PROGRAM**

JANUARY 1979

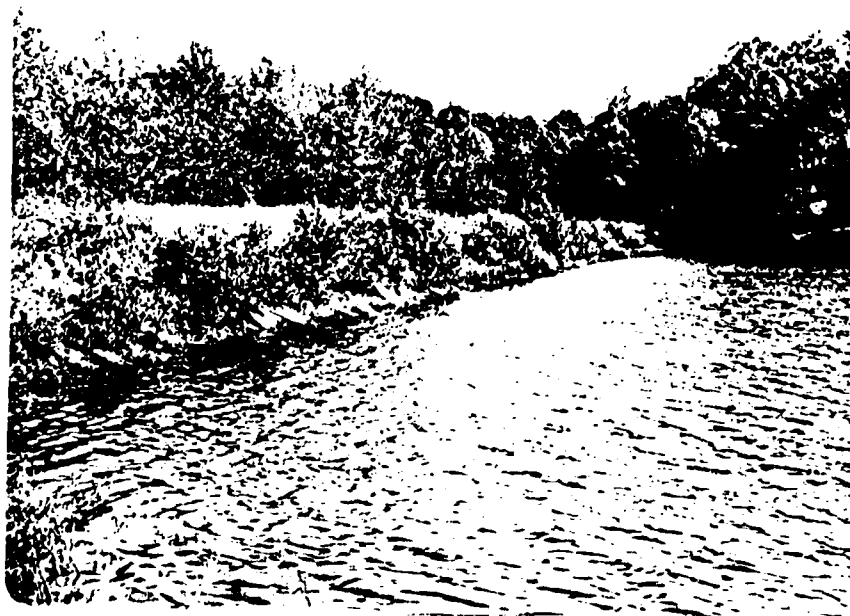
Photo 2 - View along upstream slope of dam taken from left abutment.

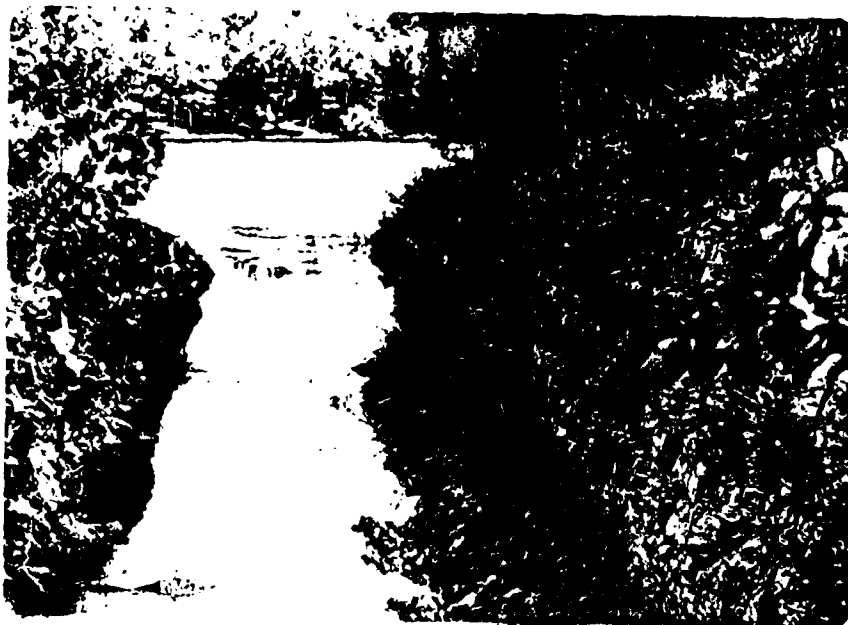
Photo 5 - View through connecting channel looking toward lake No. 2.

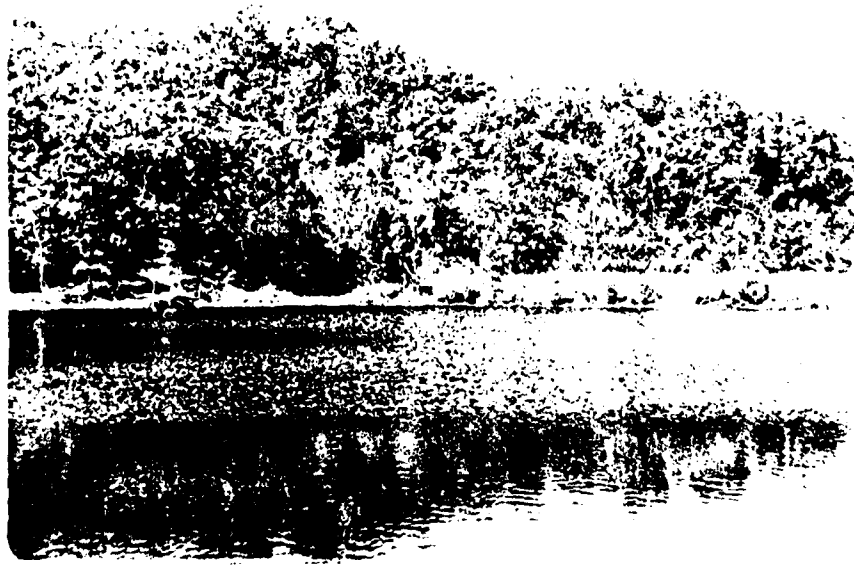
Photo 6 - Picture of upstream slope of embankment. Note spillway at left side of dam.
